OCTOBER 1967

THE NAVAL AVIATION SAFETY REVIEW

V.13 #4

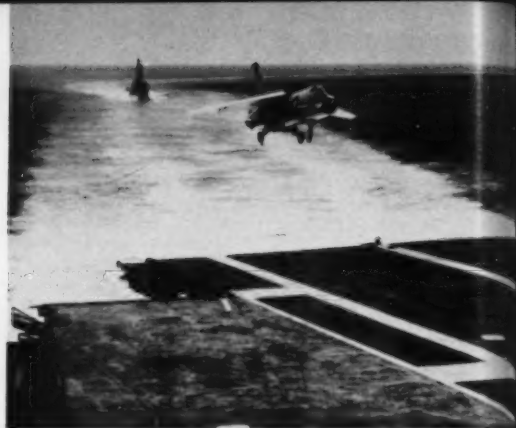
The second approach was good.

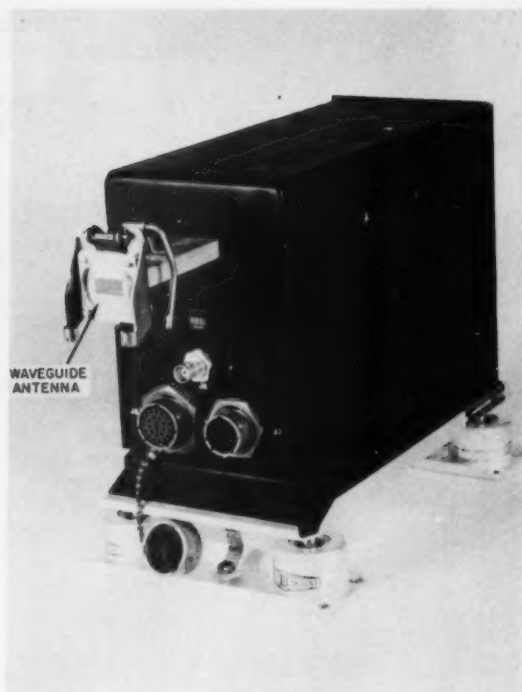
Fig. 1. AN/SPN-41 Airborne Receiver/Decoder

receiver/decoder shown in Figure 1 measures $10\frac{1}{2}$ " X $4\frac{3}{8}$ " X $7\frac{1}{2}$ " and weighs 12 lbs. If an installation space/location problem exists the receiver/decoder could be separated into a receiver package and a decoder package. Transmitters, including stabilization mechanisms, are shown in Figure 2.

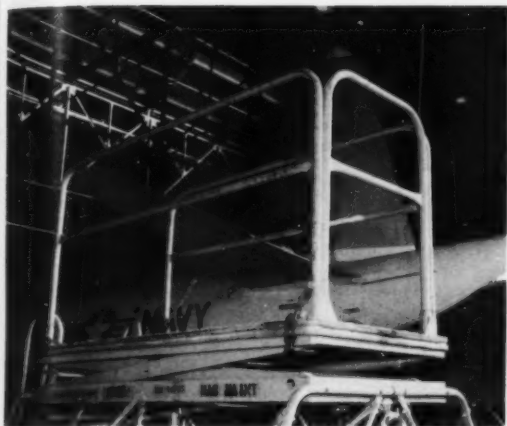
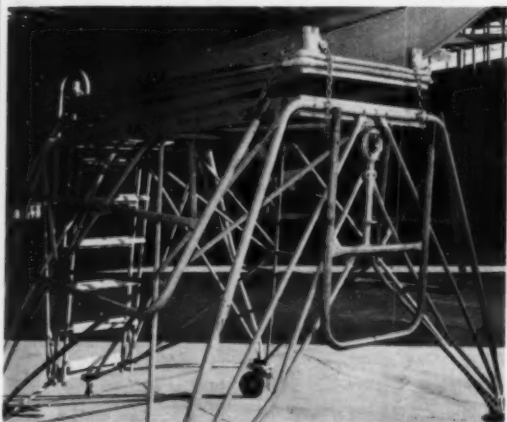
Chains fixed to workstand guard rails guarantee availability. Rails rigged (above), stowed (below).

utilize the guard rails as they were designed, thus decreasing the chance for personal injury. The fix can be done on the squadron level or by AMD during periodic check.

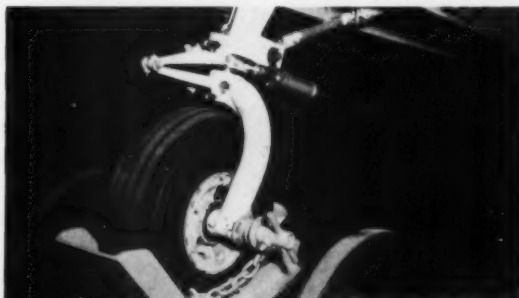
T-34 nosewheel rigged on tow trailer using new locking bar. Inset: Comparison of new and old locking bar.

A T-34B was being respotted from the line to the hangar. Enroute, the mainmounts rolled over a gas hose bridge causing a pitching movement which compressed the nose wheel oleo. This allowed the retaining chain, from the tow trailer to the locking bar (attached to the aircraft's nose wheel) to slacken. The locking bar rotated, unlocked, and separated from the nose wheel as the oleo expanded. The nose wheel then rotated to starboard and fell off the tow trailer's swivel-well. On contacting the ground, the nose wheel jammed past the 20-degree limiting bar bolt. This necessitated replacement of the nose wheel strut.

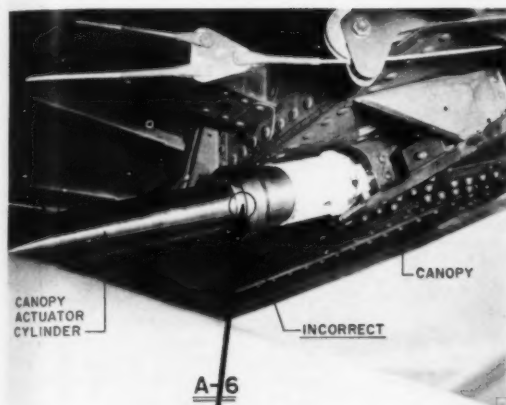
Fig. 1 PN 128HM10171-1

DURING an early morning preflight the pilot found an escape system item that just didn't look right. The locking segments on the rear of the canopy actuator appeared to be installed *backwards*. An AME and a check of a nearby A-6 confirmed his suspicions.

The canopy actuator had been repacked over the weekend and upon reinstallation of the canopy locking segments, PN 128M10171 in Figure 1 were installed backwards. With this arrangement locking retainer, PN 128HM10284 shown figure 2 will not slide over the canopy lock segments during the jet-
